Fire Risk Assessment

Prepared For: Reach Alternative Education SW Ltd

Address: South Petherton Youth Centre, Lightgate Lane, TA13 5AU

Date of Inspection: 26th February 2024

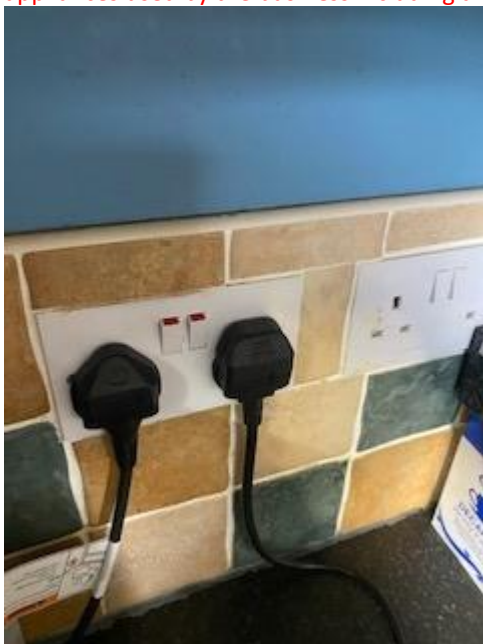
Action Required	Priority	Action by Whom	Date Completed
<p>At the time of assessment there was no evidence of an indate EICR.</p> <p>Recommendation: Instruct a competent person to complete a full EICR report or provide evidence of an in date EICR</p>	2	Dan Palmer	
<p>Portable electrical appliances were observed within the premises. There was no indication of when the portable electrical appliances last underwent PAT (Portable Appliance Testing) testing.</p> <p>Recommendation: Instruct a competent contractor to carry out PAT testing to all appliances used by the business including all electric heaters</p>

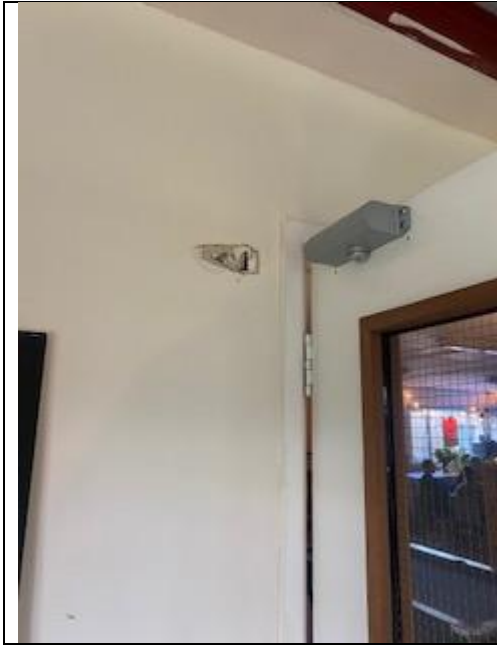
2	Dan Palmer	
<p>At the time of assessment there were areas which had compartmentation issues. There was an area brought up in the last assessments undertaken where there was a hole in the wall and this was still present</p> <p>Recommendation: Instruct a competent person to seal all holes/gaps that lead into other areas of property or to unknown areas. Adequate fire stopping needs to be carried out by a qualified and competent contractor.</p>	2	Dan Palmer

What needs to be done to make each situation safe?	Owner	Date due	Date complete
Instruct a competent person to seal all holes/gaps that lead into other areas of property or to unknown areas. Adequate fire stopping needs to be carried out by a qualified and competent contractor.	Dan Palmer	Immediately

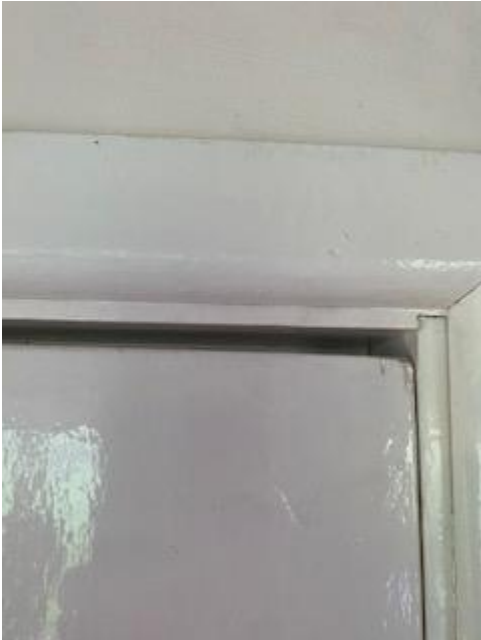
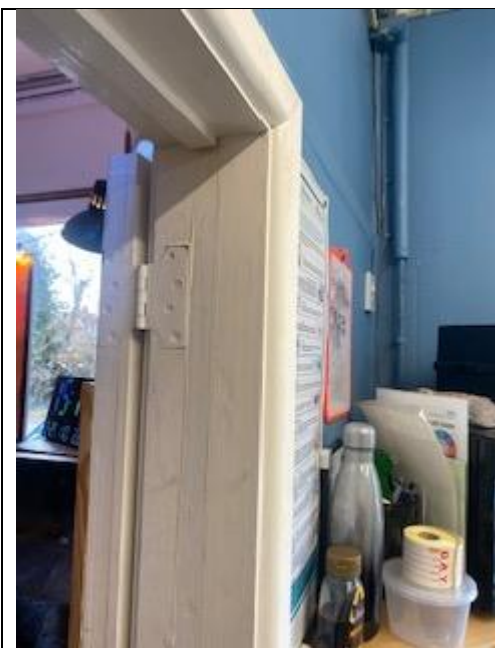
Small Office

<p>At the time of assessment no all door were fire doors in the areas which are required.</p> <p>Admin Door – Not a fire door. The room has got flammable materials stored within and has got eletrical products which could create a fire. This does not meet the standards of BS 476 Part 22</p> <p>Duty Office – Only 2x grade 13 hinges. 3x fire rated hinges to gade 11 or above are required on fire doors. This does not comply with BS EN1953 regulations. Intumescent Strips were not installed on the door frame or door present. This does not comply with BS 8214:2016. A self-closing device was not installed at the time of assessment. This does not comply with BS EN 1154</p> <p>Table Tennis Door Hinges – there was no evidence that the hinges installed were fire rated. No grade of hinge was evident. This does not comply with BS EN1953 regulations. Intumescent Strips - Intumescent Strips were installed with full door coverage. This complies with BS 8214:2016 Self-closers – A self-closing device was installed and was functioning correcty. This complies with BS EN 1154</p> <p>Kitchen Hinges – there was no evidence that the hinges installed were fire rated. No grade of hinge was evident. This does not comply with BS EN1953 regulations. Intumescent Strips - Intumescent Strips were not installed on the door frame or door present. This does not comply with BS 8214:2016 A self closing device is installed viaa automatic closer is the fire alarm was to sound</p>	<p>1</p>	<p>Dan Palmer</p>

Hinges – The hinges installed were fire rated. This complies with BS EN1953 regulations

Intumescent Strips - Intumescent Strips were not installed on the door frame or door present. This does not comply with BS 8214:2016

Self-closers – A self-closing device was not installed at the time of assessment. This does not comply with BS EN 1154

Recommendation:

Instruct a competent person to install a minimum FD30 Fire door to the admin office with all the correct fire rated fixtures.

Instruct a competent person to install a self-closing device to all fire doors, 3x fire rated hinges to grade 11 or above, intumescent strips and cold smoke seals, fire rated handles and locks.

When doors are fitted it is important to ensure that gaps between door and frame do not exceed 4mm.
